Title: Exploring Neutron Imaging for Non-DE Analysis of corrosion in ICCWR of 3013 Containers

Intended for: Corrosion Working Group Meeting, 2021-02-23/2021-02-24 (Los Alamos, New Mexico, United States)

DOE stores excess weapons plutonium in nested, welded stainless steel containers (3013 Containers)

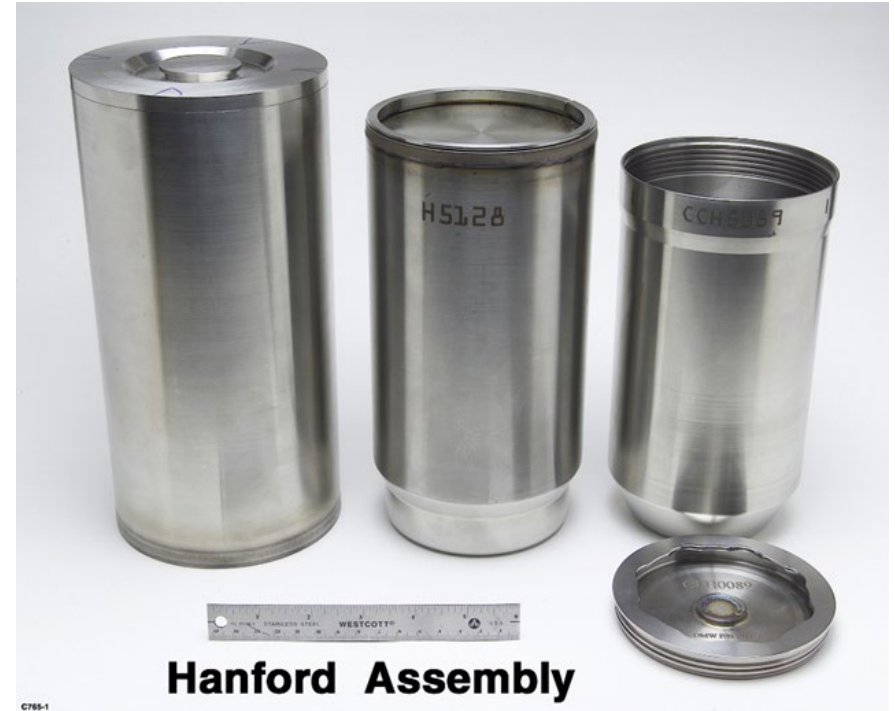
3013 containers: 3 layers

1. Convenience container (different features depending on origin, some have filters for outgassing, ie: Hanford-Livermore)-CC. In contact with material.
2. Inner container (welded)-IC. In contact with gases generated by the material.
3. Outer container (welded)-OC.

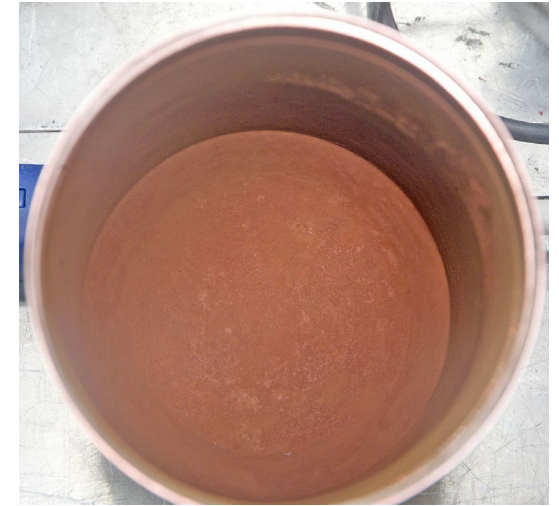
Convenience Can

DE of some 3013 container packaged with chloride-bearing PuO_2 and moisture have shown corrosion on the convenience and inner containers.

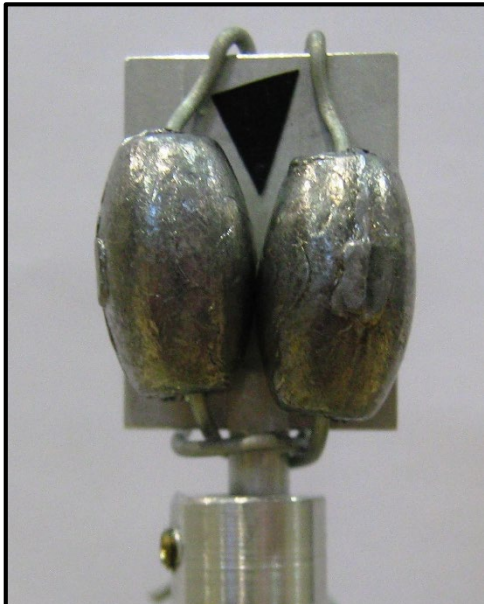
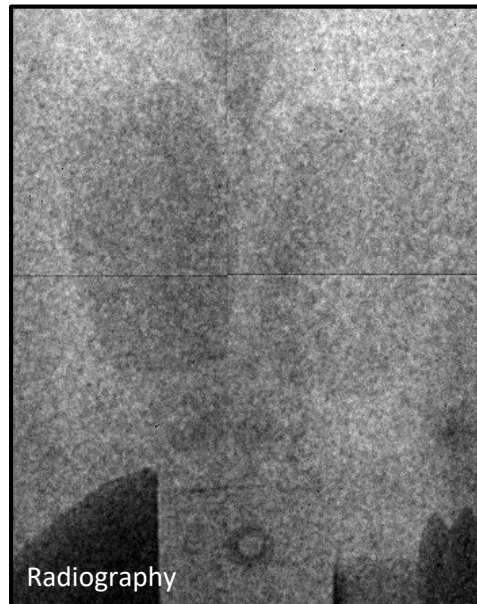
PCI of Pb fishing weights:

Due to the low absorption contrast, a radiographs contain little information (center).

Phase contrast imaging ($\sim 50\mu\text{m}$ resolution) was used to enhance the visibility of interfaces and interior defects in the Pb (right).

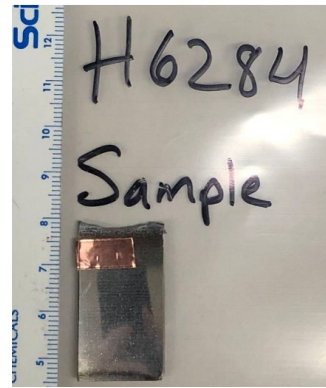
Transmission based neutron radiography does not detect any inhomogeneity in the fragment. Using in-line propagation imaging, ~100-500 micron features appear at the top of the sample. Increasing propagation distance increases contrast but decreases resolution.

250mm propagation
